HURRICANE "CAMILLE"

An Appreciation of the Damage As Interpreted
from Aerial Photography

Resource Evaluation Division
National Resource Analysis Center
Office of Emergency Preparedness

August 29, 1969

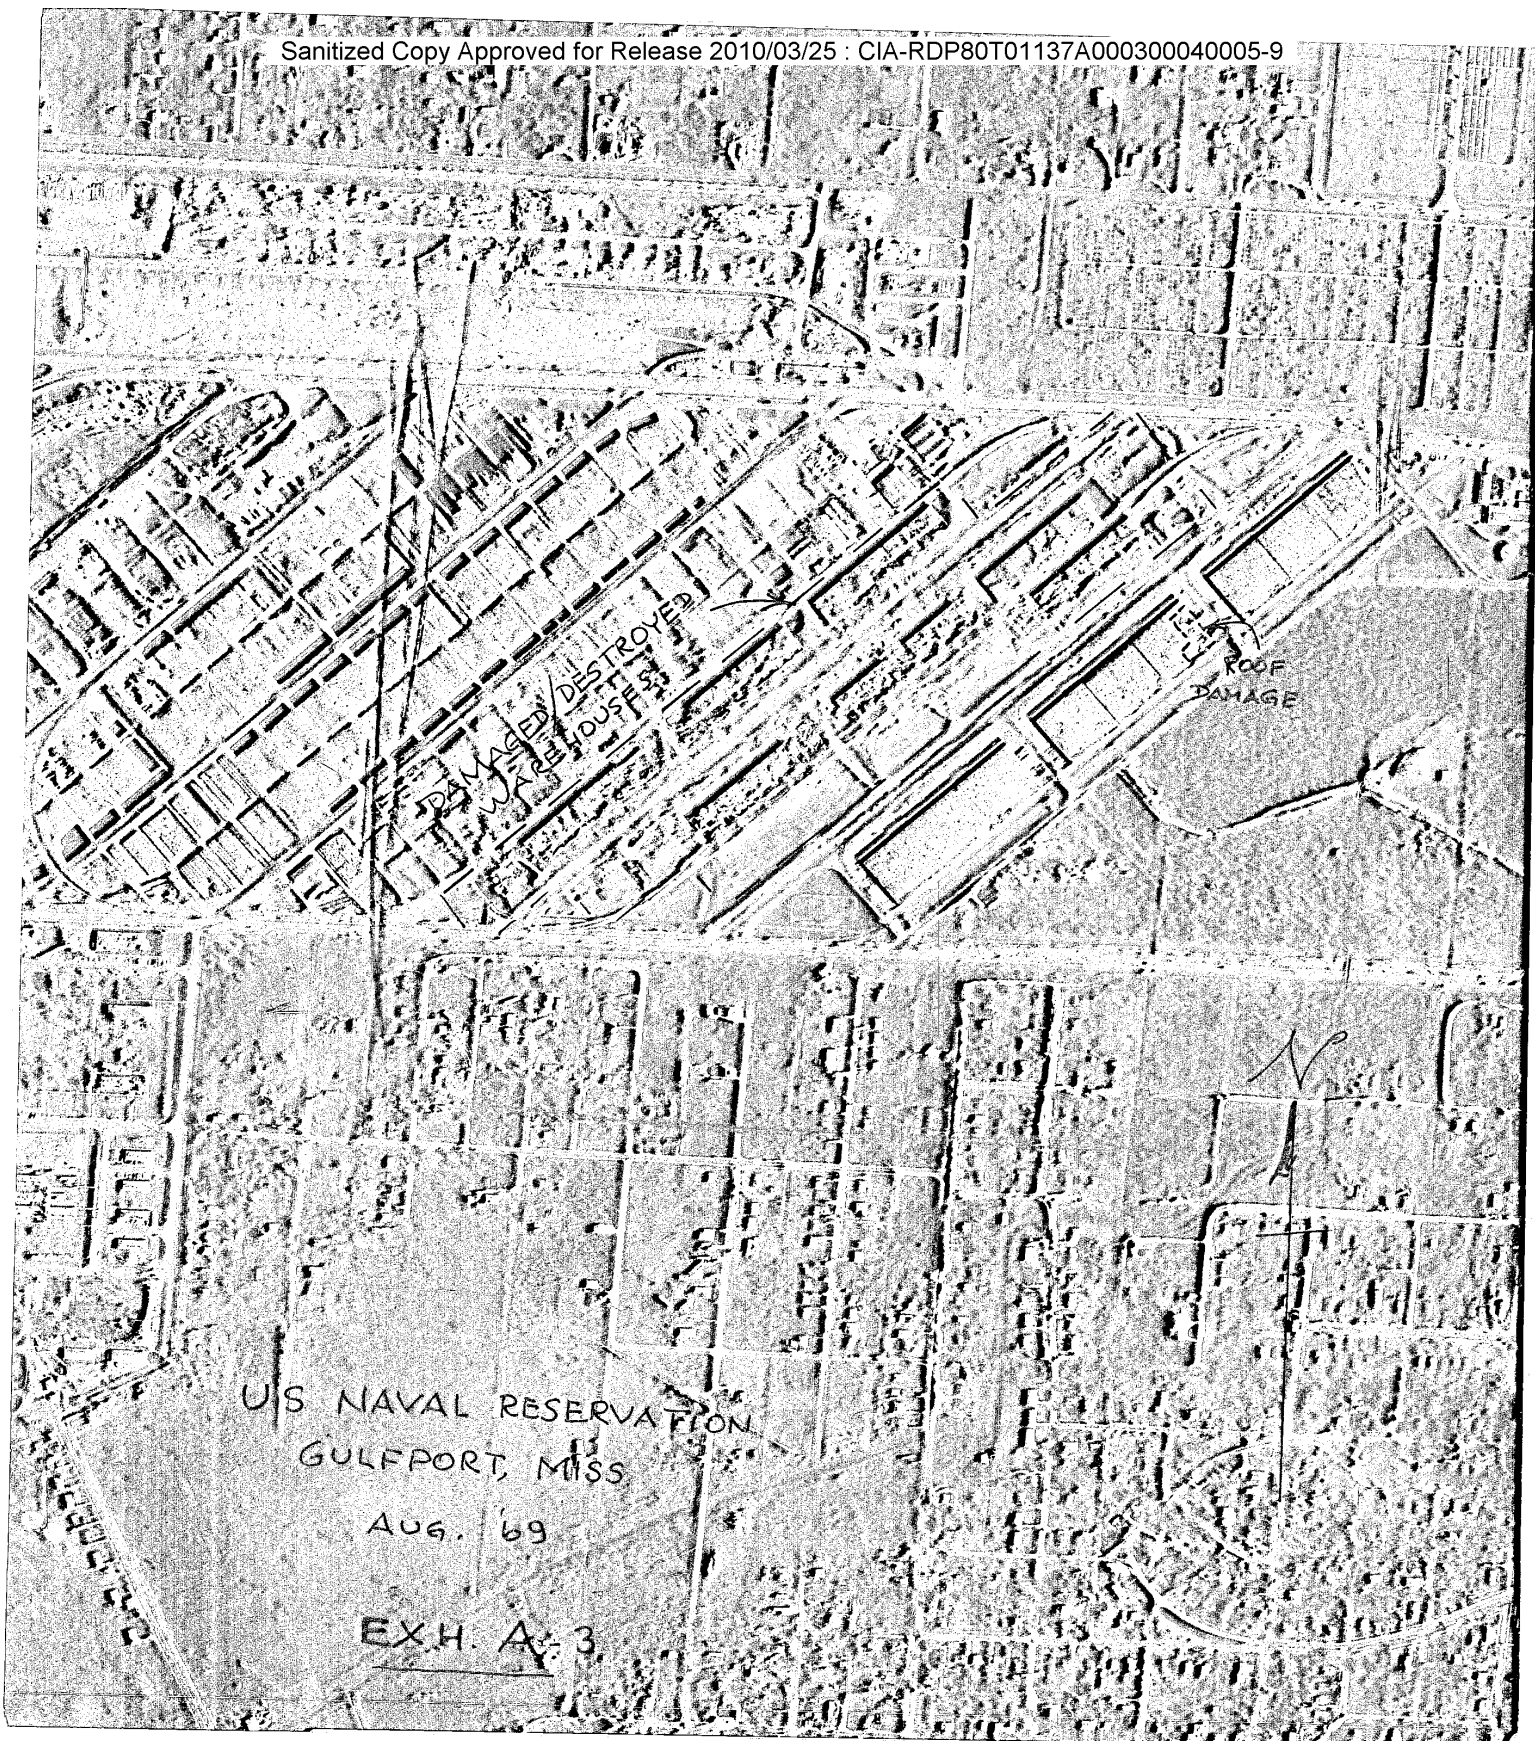
EXH. A-3

- 6 large warehouse buildings (550' x 110')
almost totally damaged
- 4 warehouses (230' x 90') destroyed
- 17 warehouses (185' x 40') severely damaged

U.S. NAVAL RESERVATION
GULFPORT, MISS

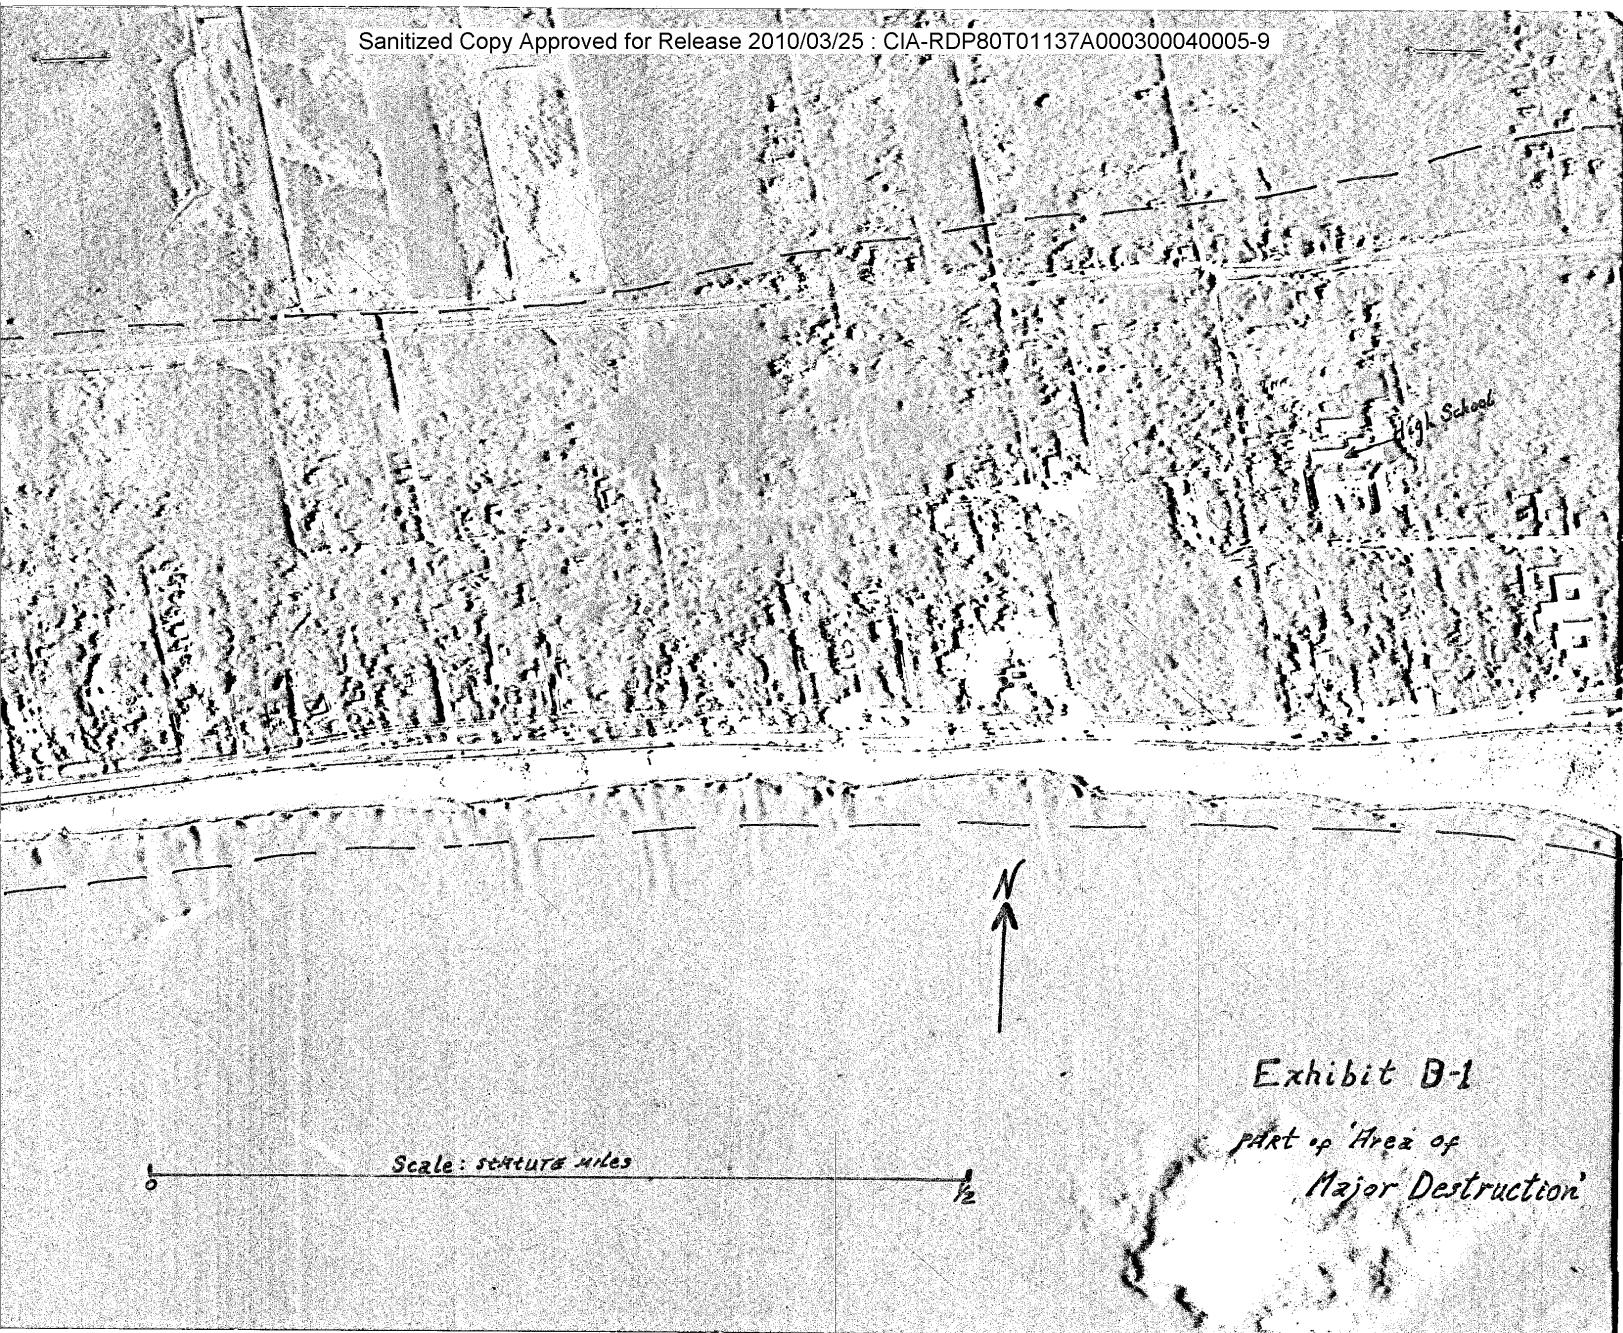
Exhibit B-1

Residential Section

An area of major destruction. Of more than 200 buildings previously standing, about 1/2 appear to have been destroyed.

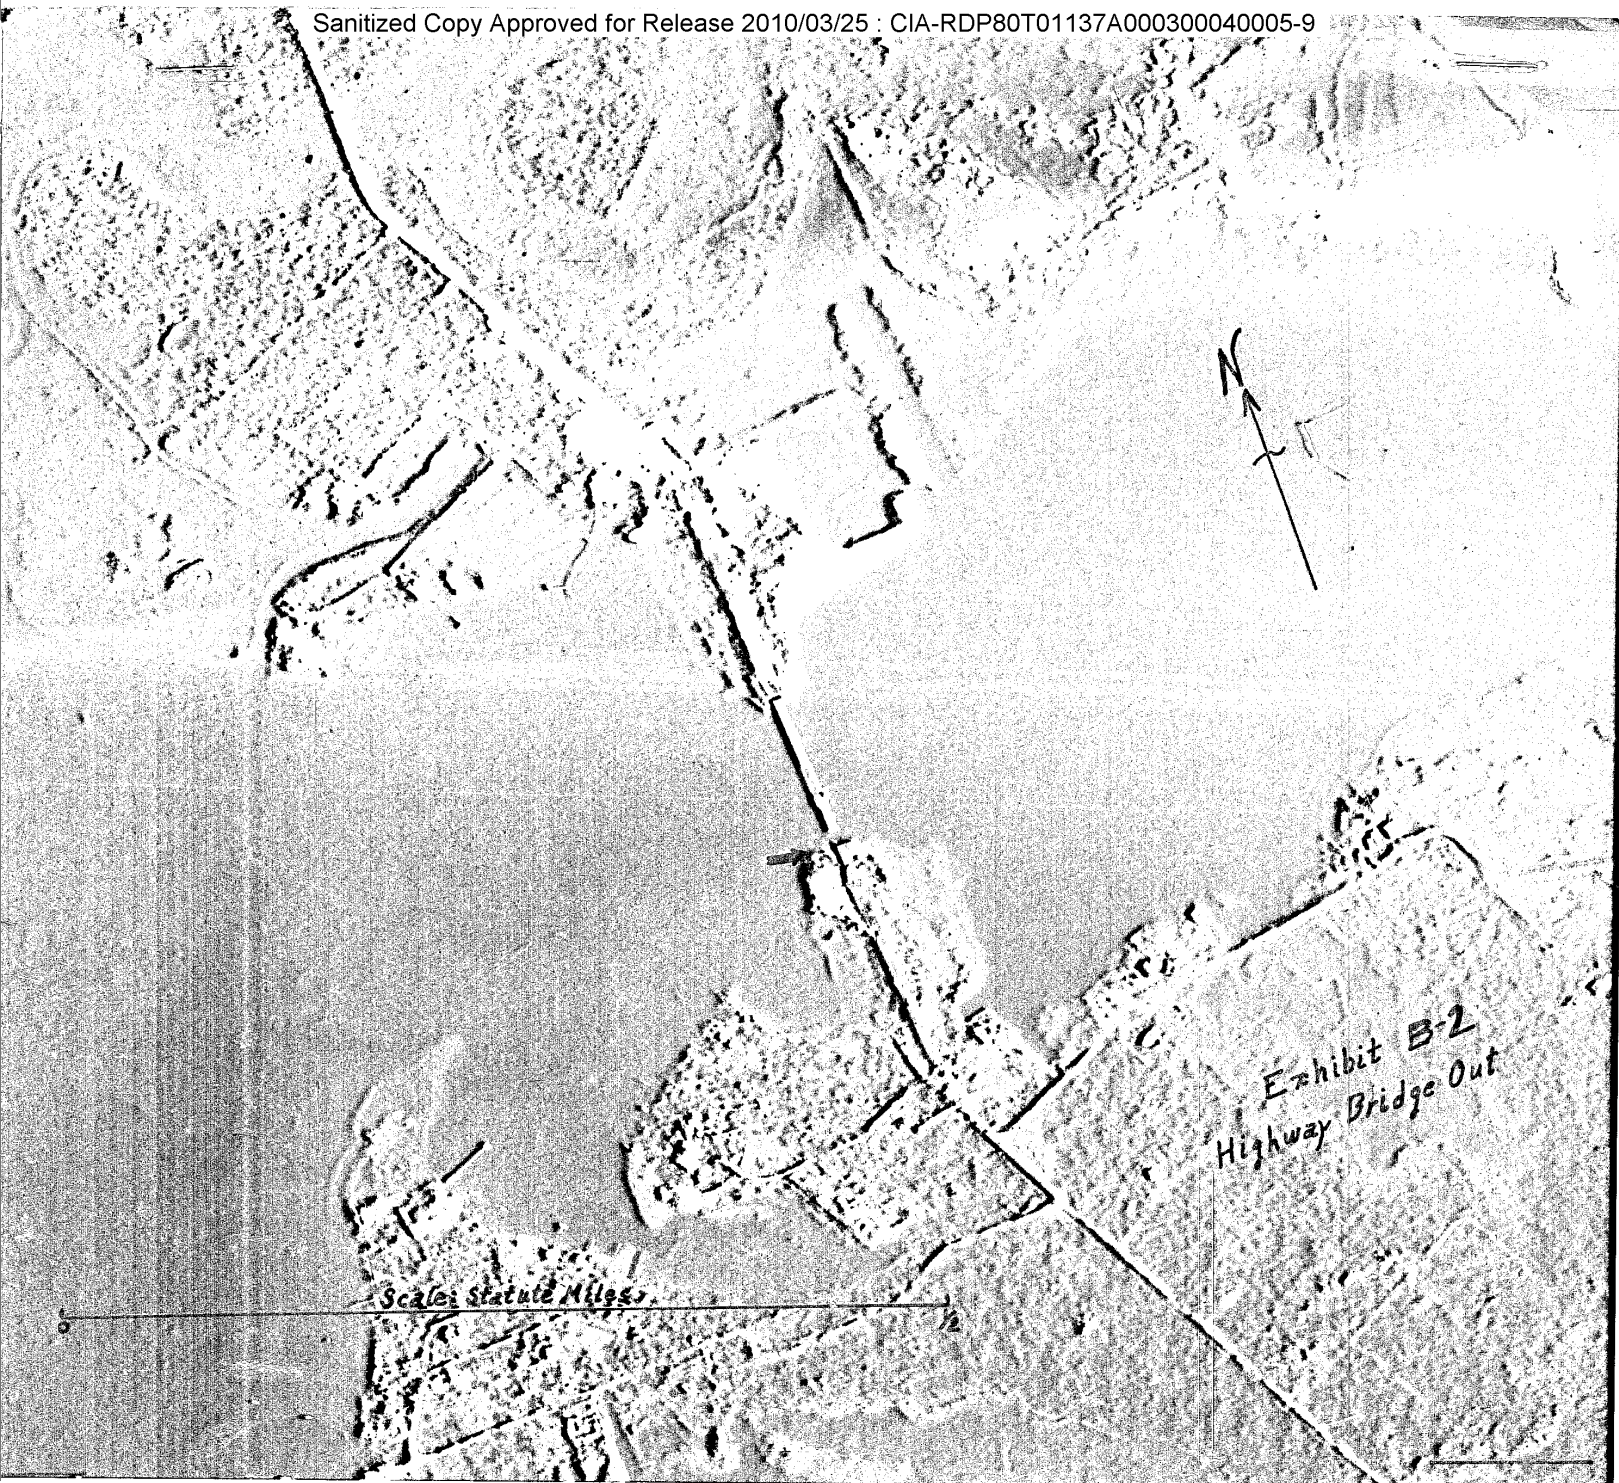
Exhibit B-2

Highway Bridge

Highway Bridge about 2 miles north of Pass Christian crossing Bayou Portage, was partially damaged. One span is out and damage is visible on another.
